SPEERS RUN DAM
NDI Pa - 505 .

PHASE I INSPECTION REPORT,
NATIONAL DAM INSPECTION PROGRAM. ✓

Speers Run Dam

PHASE I INSPECTION REPORT
NATIONAL DAM INSPECTION PROGRAM
SPEERS RUN DAM
NDI# PA-505, PENNDER# 63-6

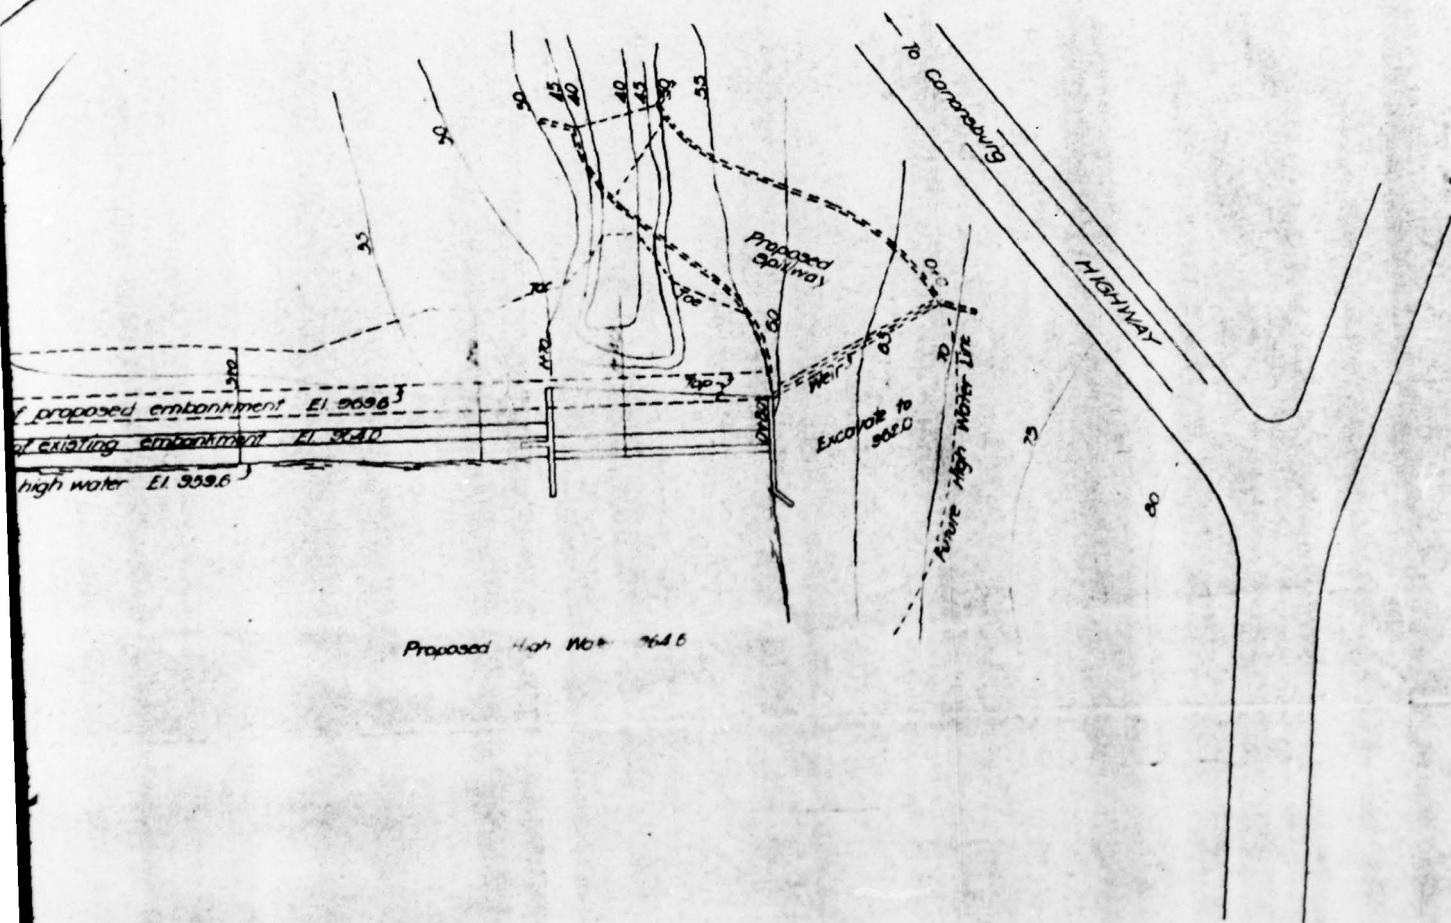
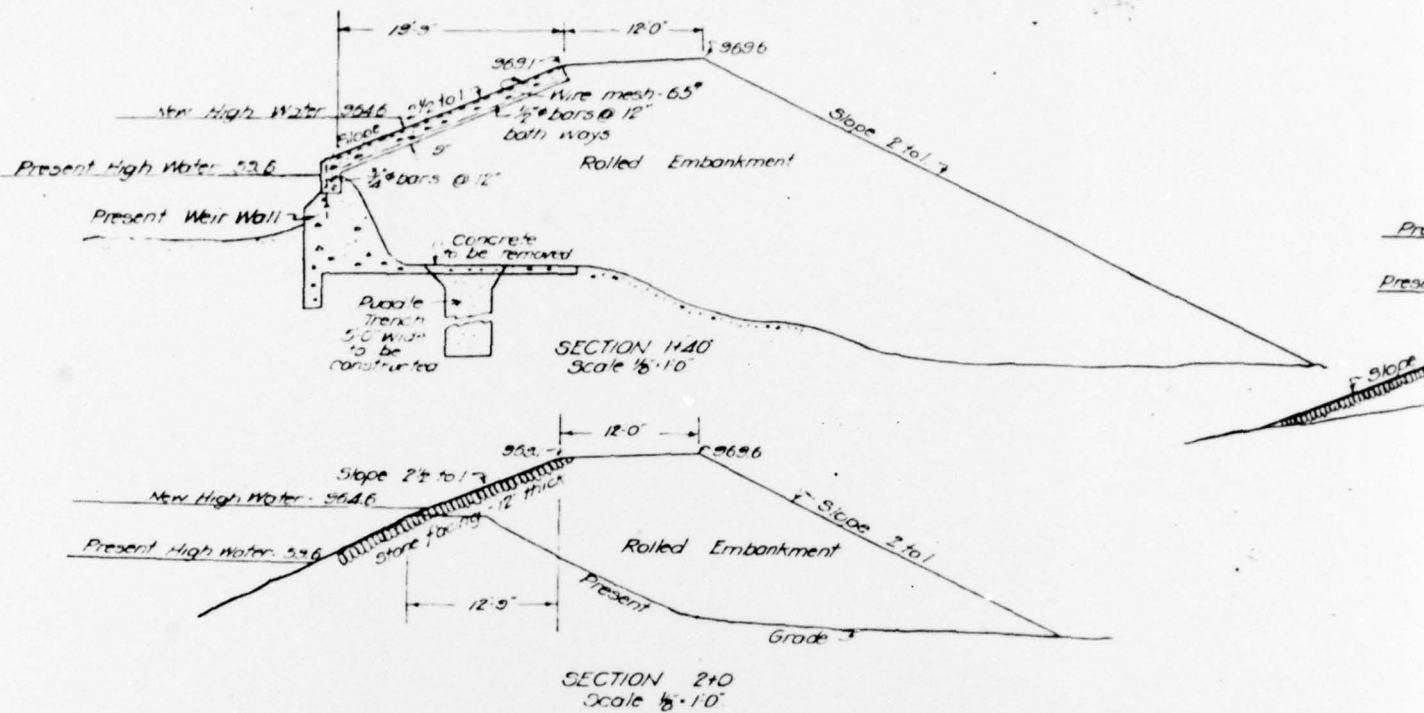
FIGURE 2

1. Embankment. Drawings indicate the embankment was constructed of rolled earthfill with a crest width of 12 feet. The original embankment which was constructed prior to 1927 (no records are available) was incorporated into the present structure and currently functions as a part of the upstream portion of the dam (see Figure 5). Presumably, near the time of construction of the original embankment, the Chartiers Southern Railroad constructed an embankment that ran tangent to the dam at the left end angling downstream as it moved from left to right relative to the dam (see Figure 2).

According to records supplied by PennDER, the Speers Run embankment is 42 feet high. The field survey, however, indicated a maximum height of 21 feet. This condition has apparently resulted from the construction of the railroad embankment which encroached over a portion of the downstream slope of the dam (see Photograph 2 and Figures 2 and 6).

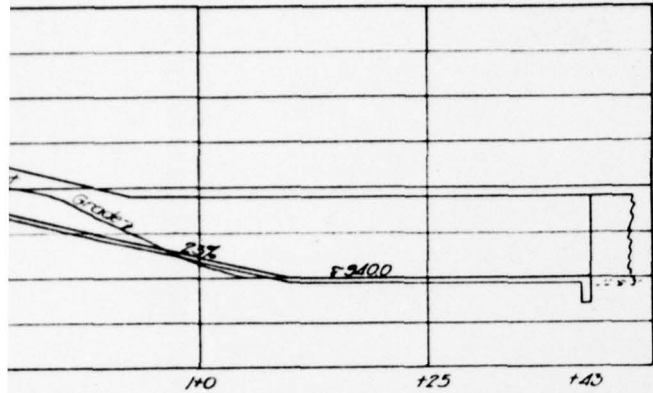
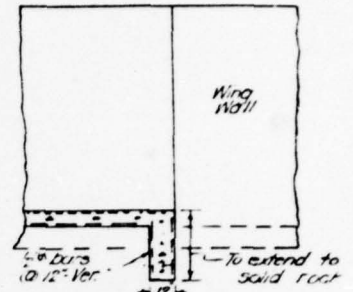
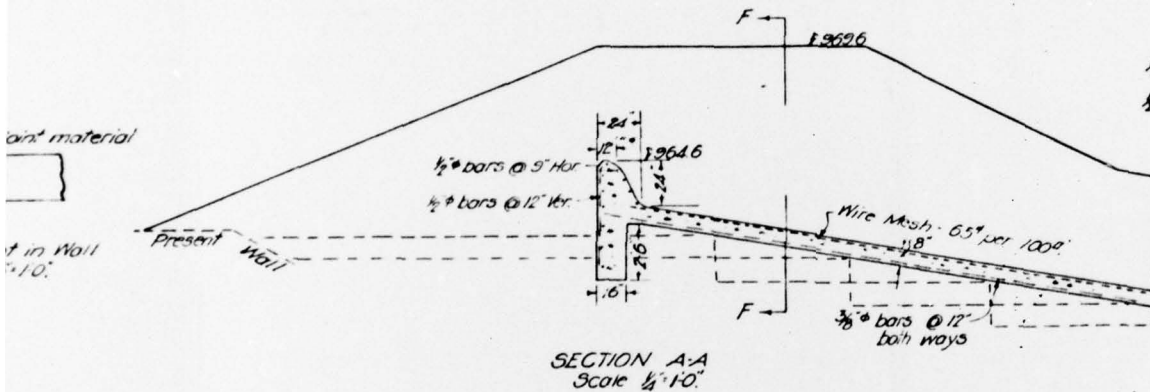
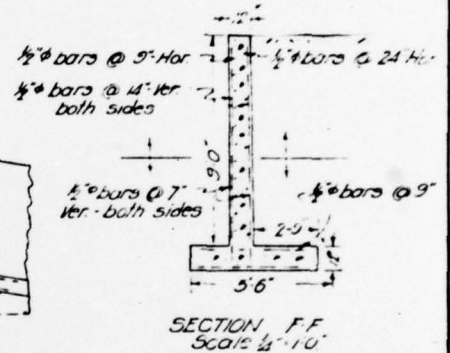
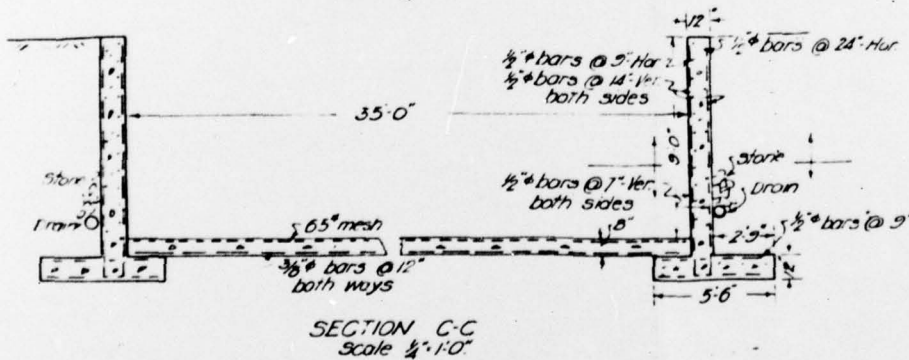
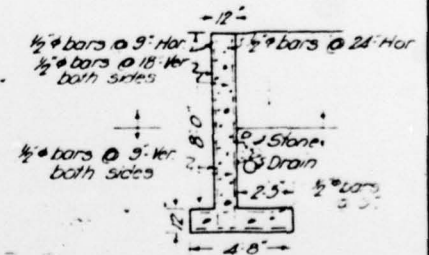
FIGURE 4

a) Spillway. The spillway is a concrete structure with an ogee-shaped crest at the entrance located along the right abutment (see Figures 2 and 4, Photographs 1, 4, and 5).

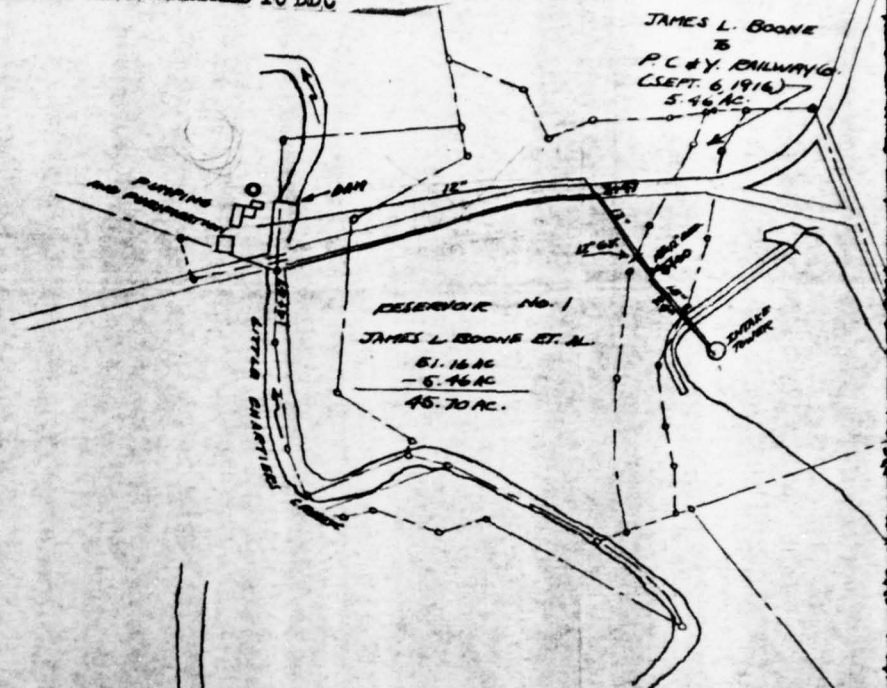
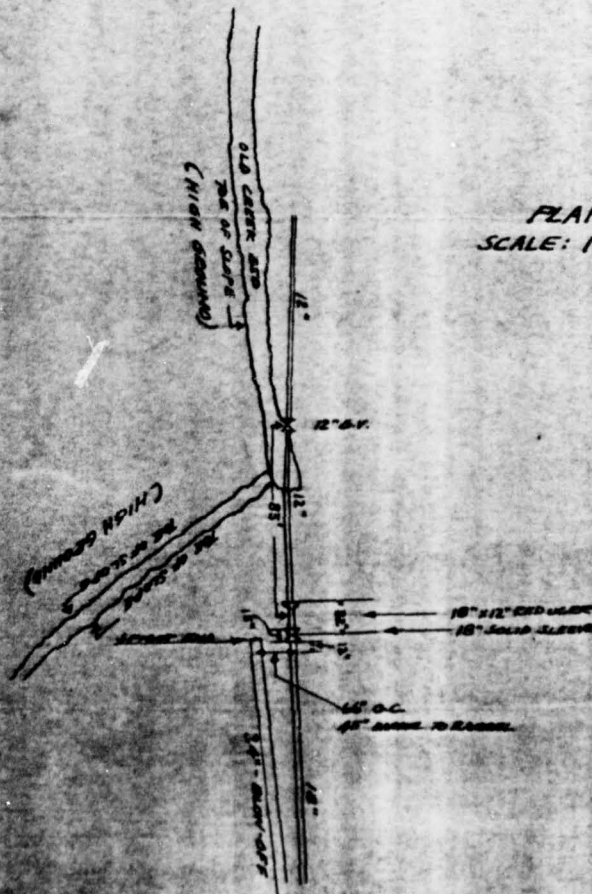
FIGURE 6

b) Outlet Conduits. An 18-inch diameter supply line and a 24-inch diameter blow-off line originate at the intake tower reportedly located along the left side of the embankment. Both lines probably pass beneath both the dam and railroad embankment and reportedly emerge at some point downstream (not located by the field team) (see Figure 6).
